Navajo Abandoned Uranium Mine Site Screen Report

Haystack Mines AUM Site

Navajo AUM Eastern Region

May 2009

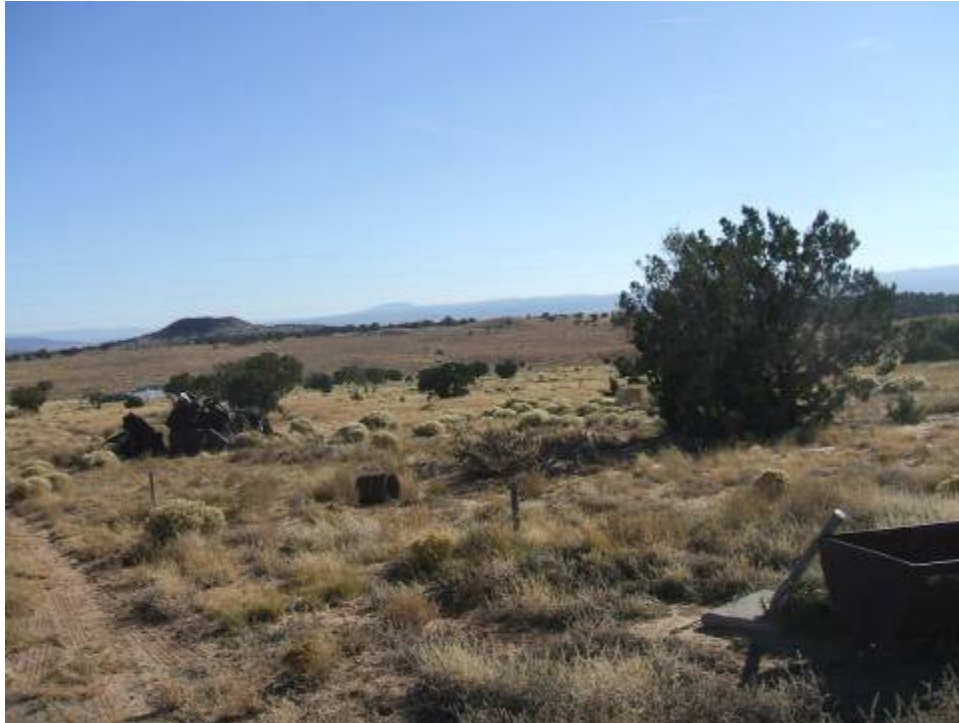
Photo 3. Haystack mine site 1039, towards the south

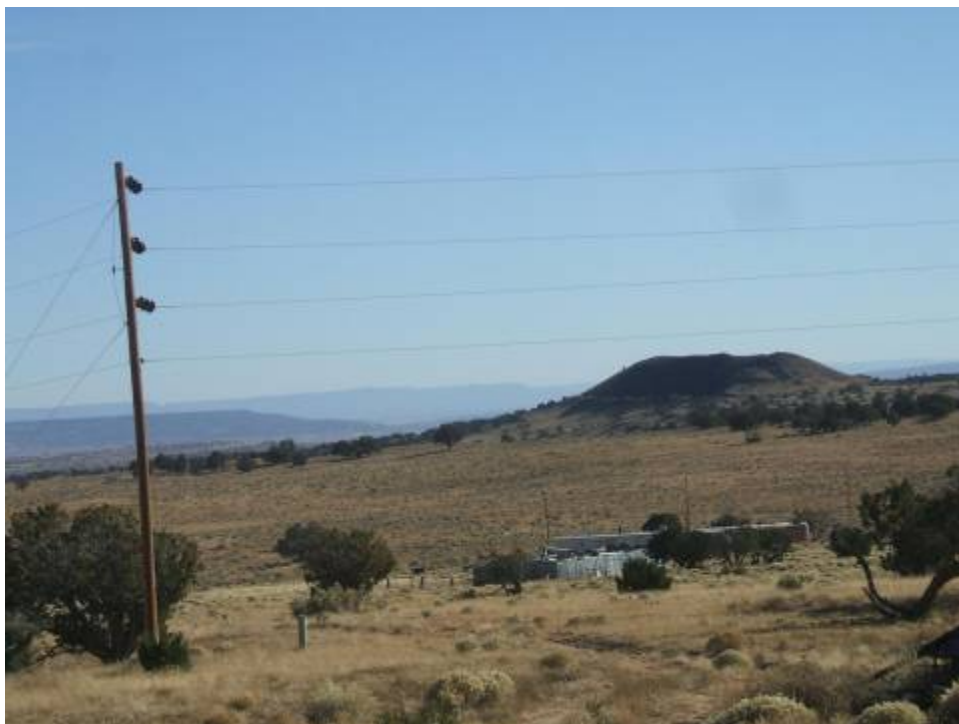
Nearby Structure Perimeter – Houses southeast of 1039

#1 8,780 cpm

#2 13,500 cpm

Photo 4. Haystack mine site 1039, houses approximately 750 feet southeast of site, towards the south

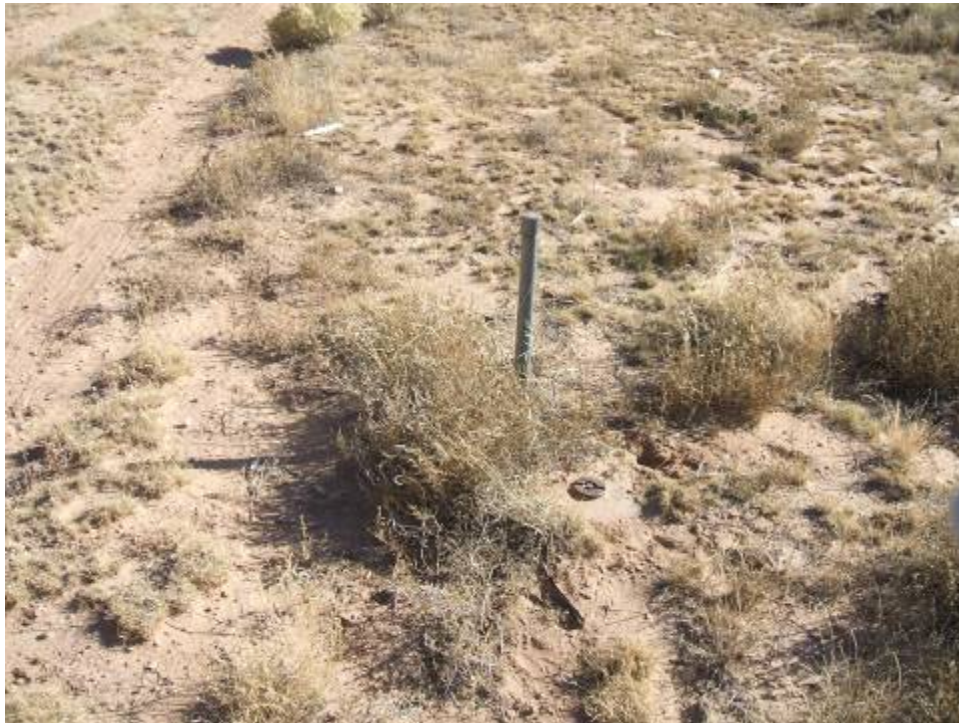
Photo 5. Haystack mine site 1039, water pipe, towards the south

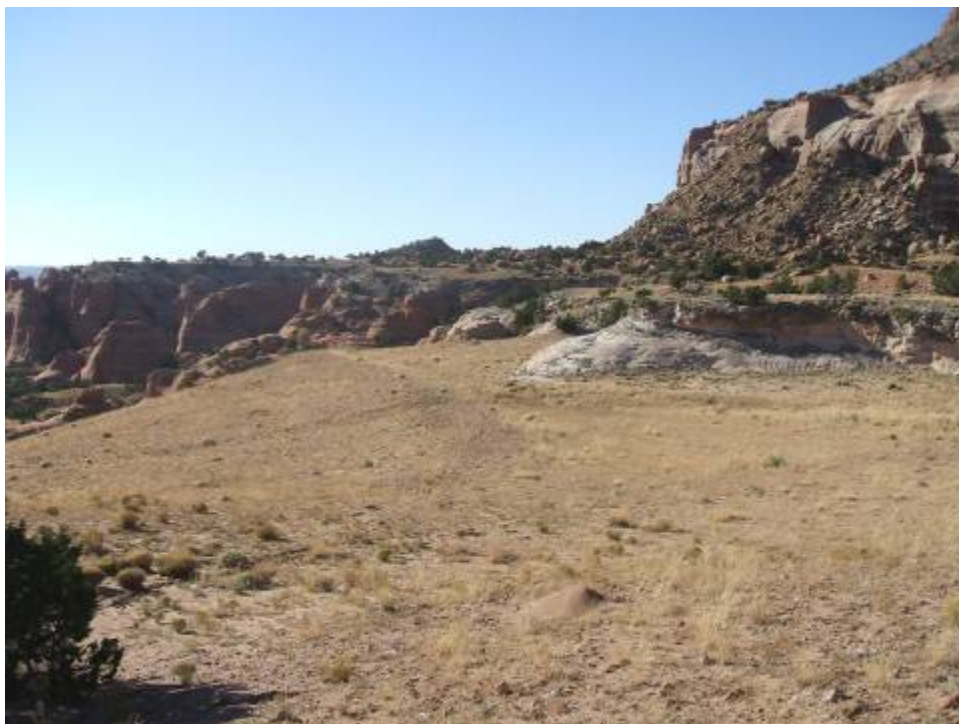
Photo 6. Haystack mine site 342, towards the northwest

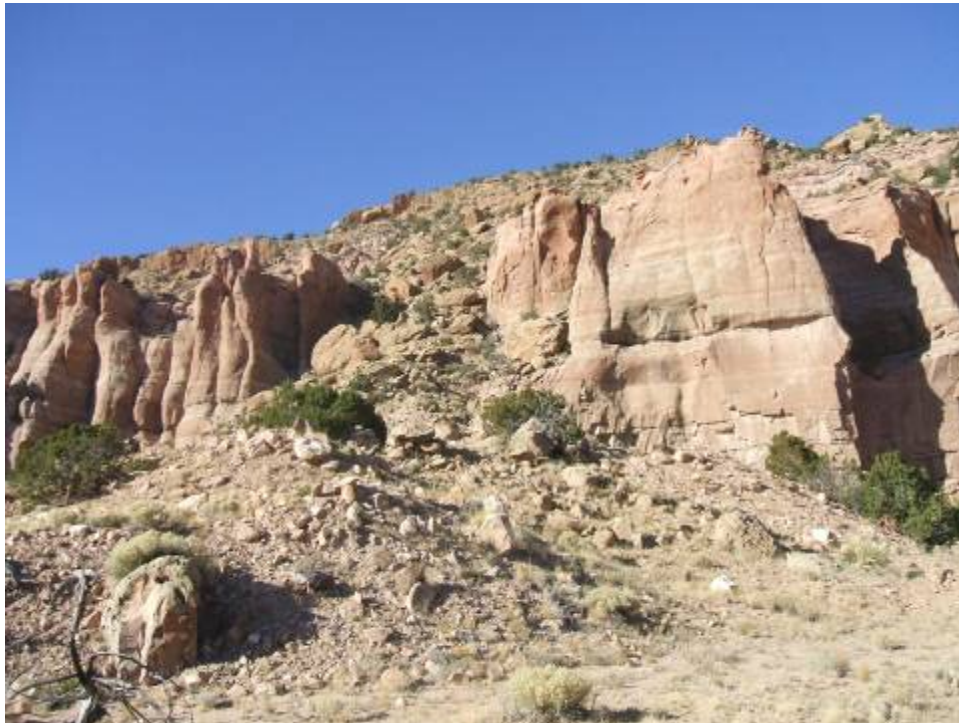
Photo 7. Haystack mine site 1038, towards the north

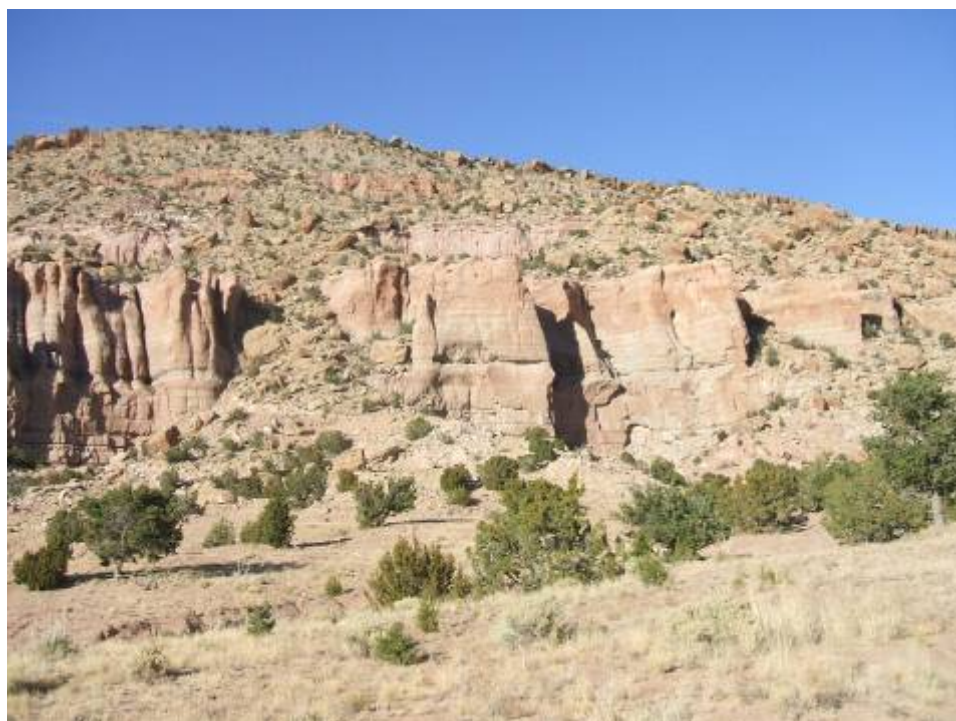
Photo 8. Haystack mine site 1038, towards the north

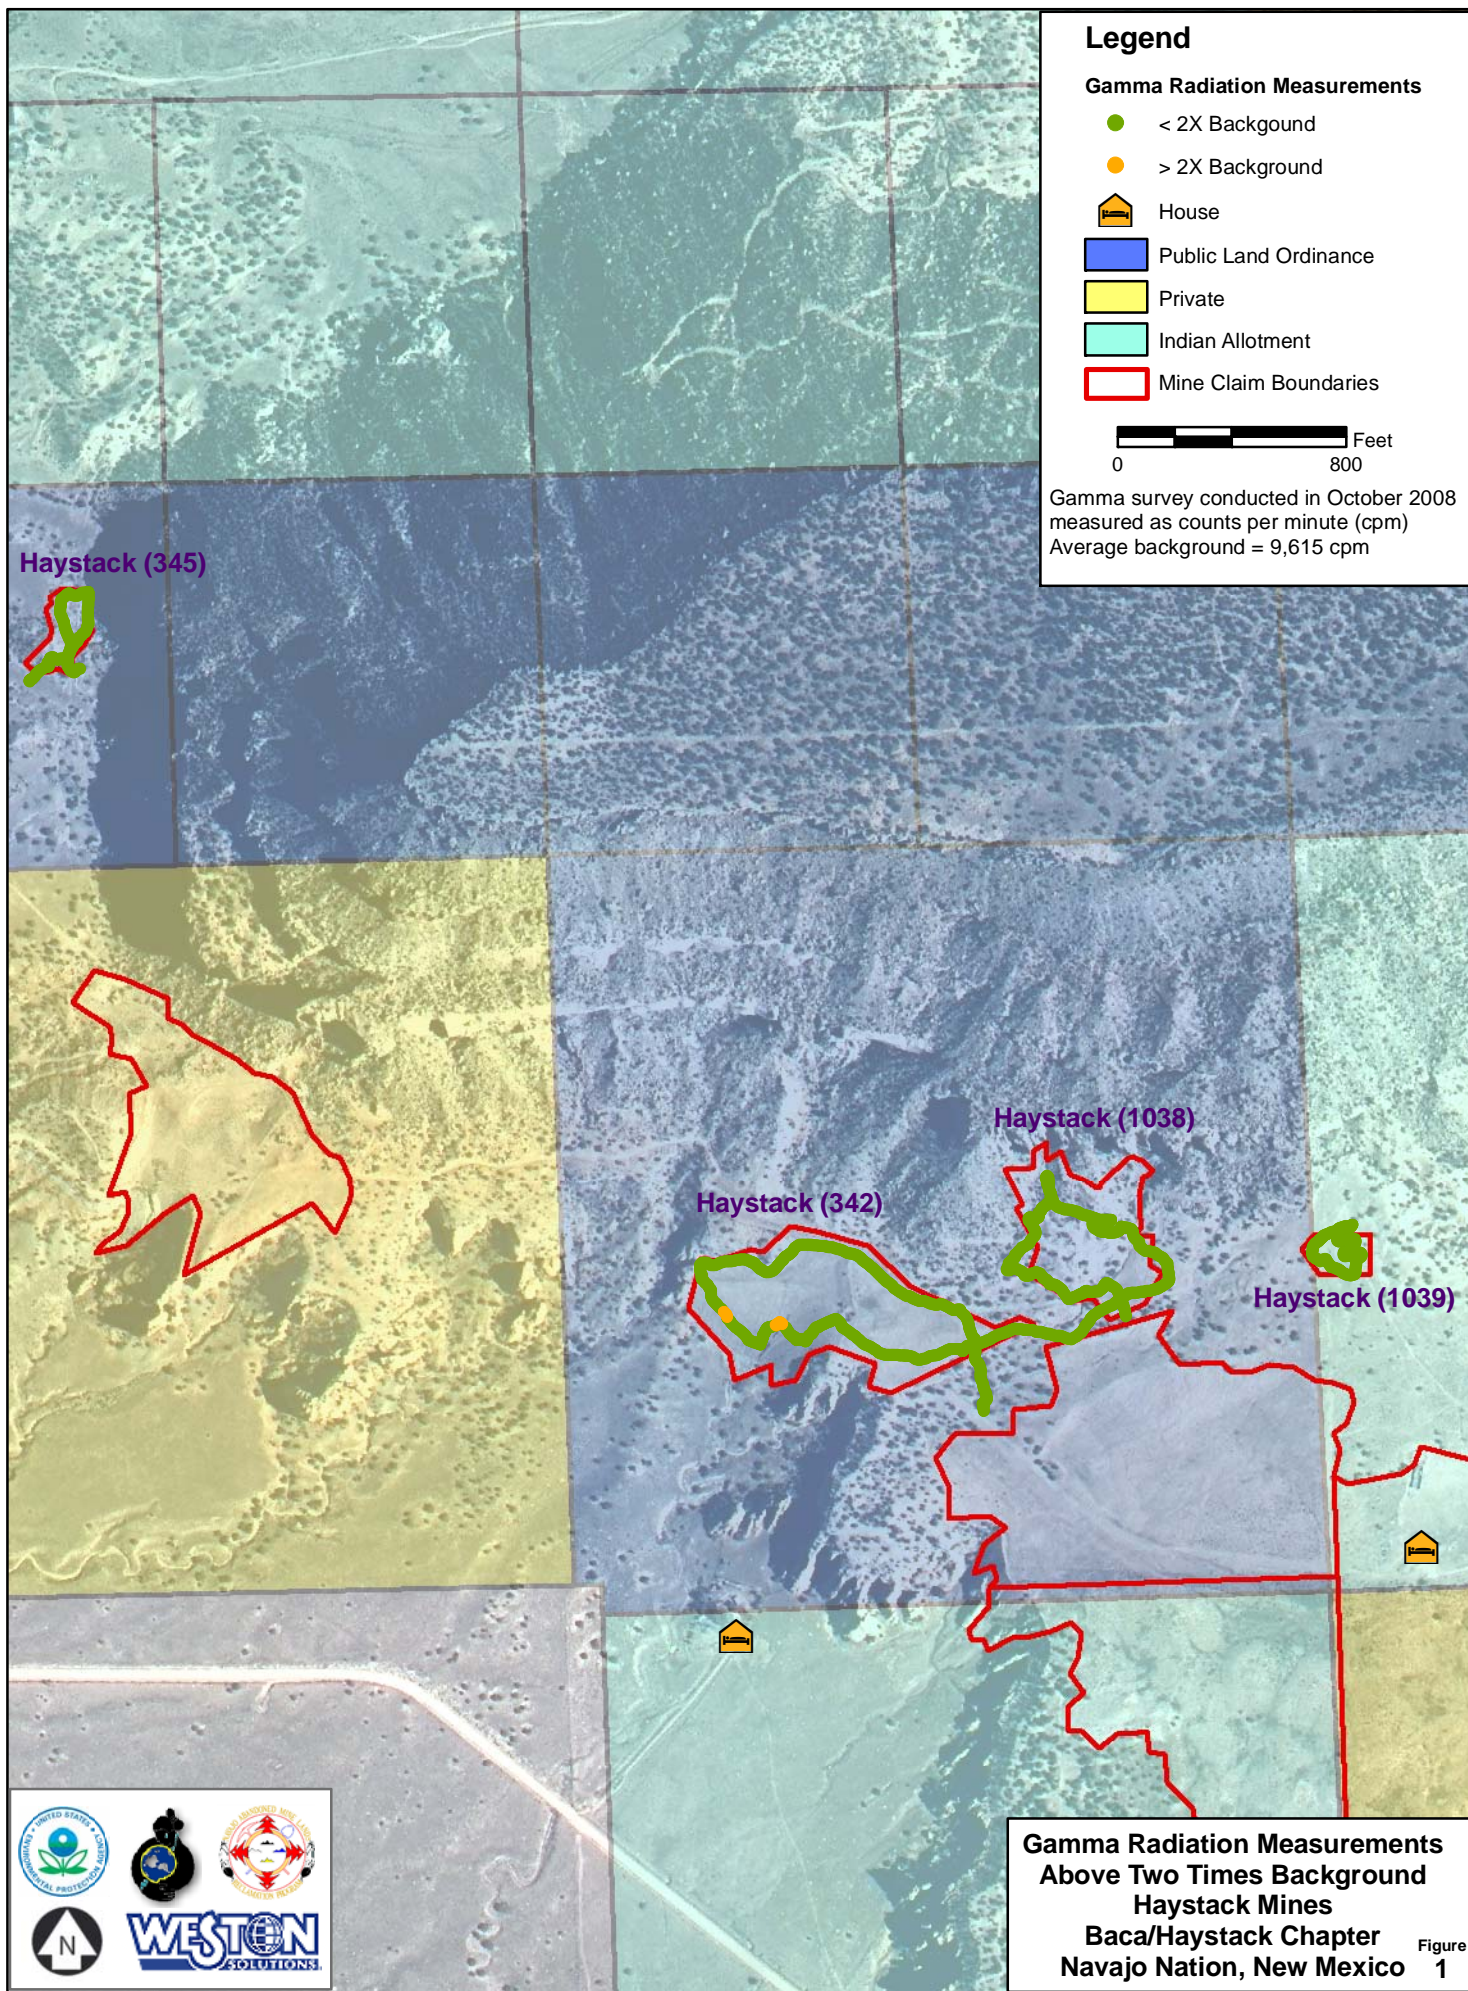
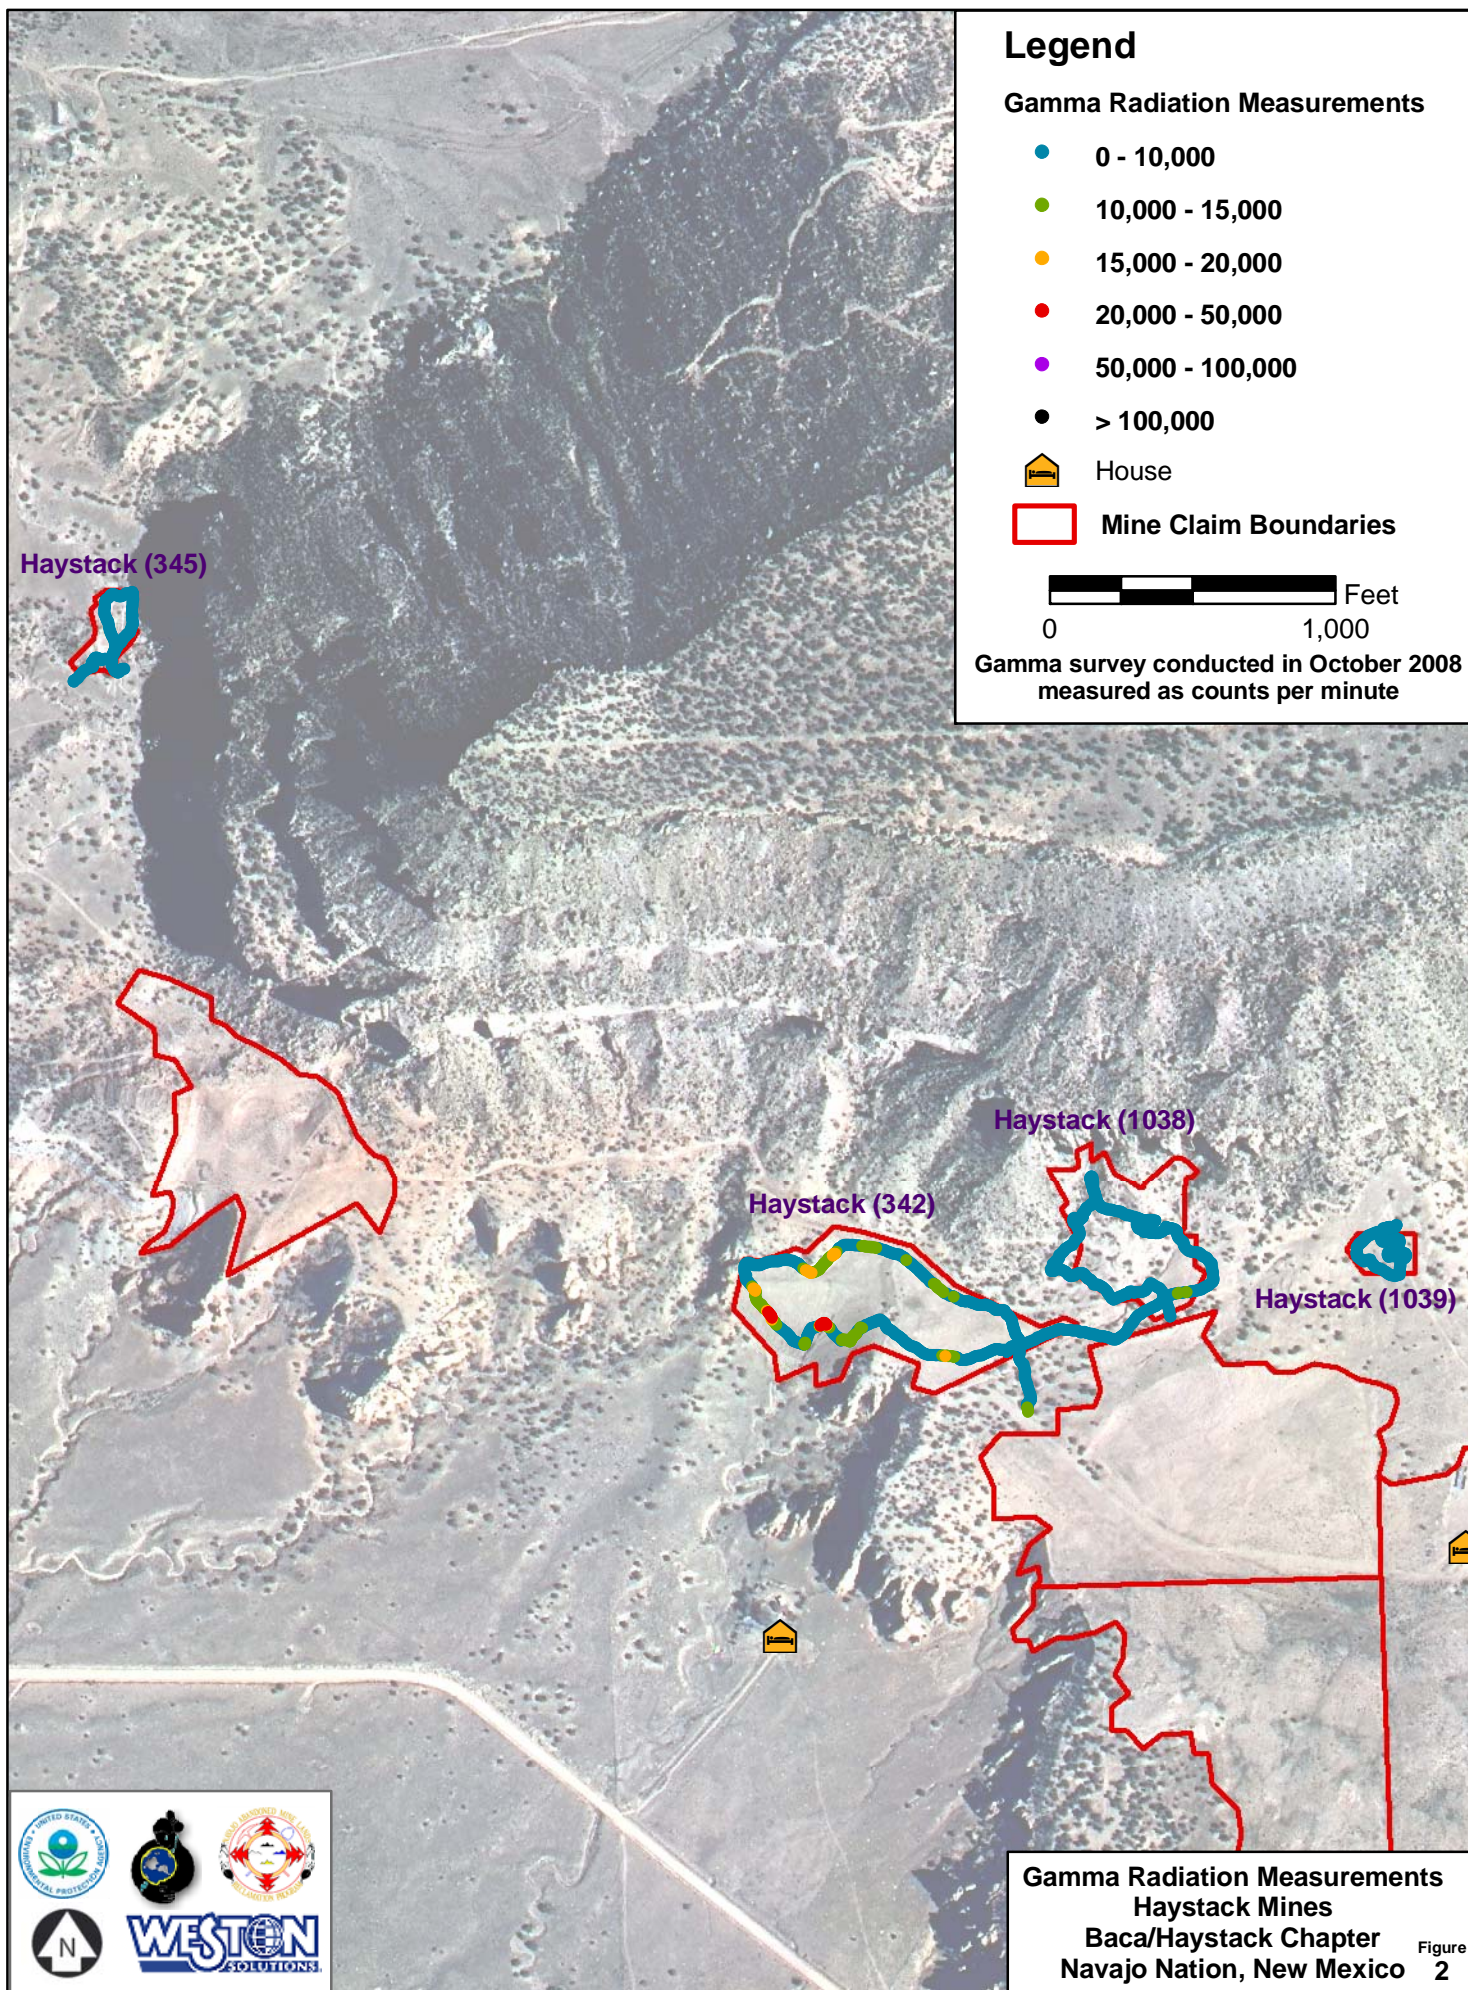
A total of 2,223 gamma radiation measurements were collected from the mine sites, ranging from 6,074 cpm to 33,870 cpm. The measurements are represented in Figures 1 and 2.

Presented in Figures 1 and 2
